RADC-TR-84-183
Final Technical Report
September 1984

EOS PROTECTION FOR VLSI DEVICES

Martin Marietta Denver Aerospace

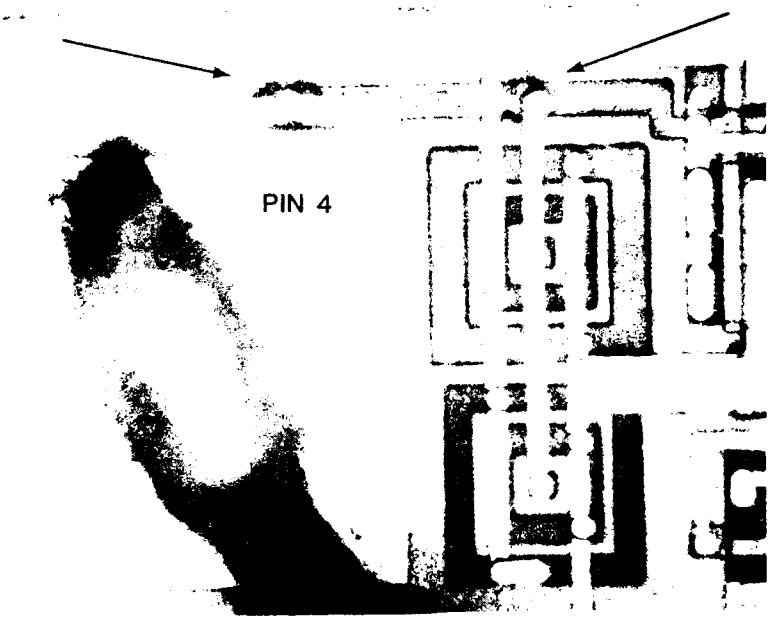
Figure V.A.21 - CD Stress, Pin 4 Input Polysilicon Damage

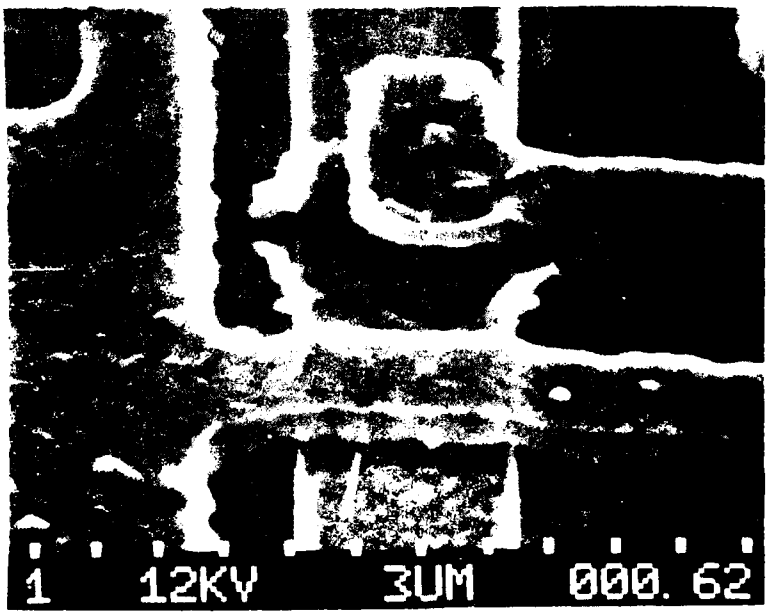
Figure V.A.22 - CD Stress, SEM Micrograph of Pin 4 Polysilicon at Diode Metalization Contact

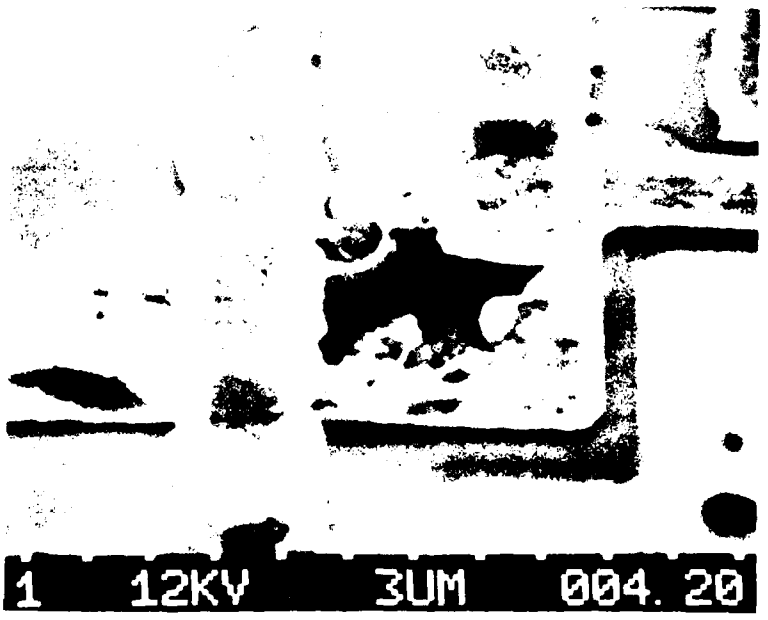
Figure V.A.24 - CD Stress, SEM Micrograph of Pin 11 Input Polysilicon.

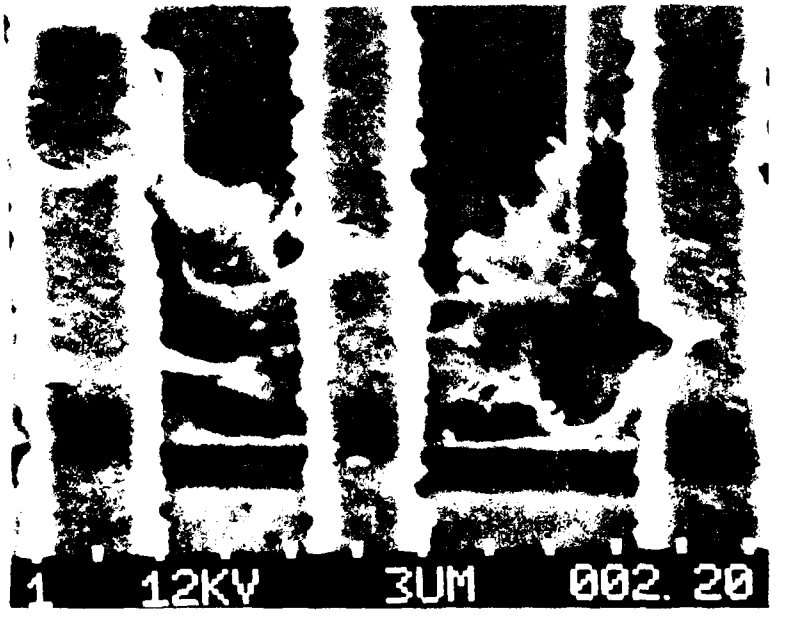
Figure V.A.26 - CD Stress, SEM Micrograph of Pin 8 Input Polysilicon Damage

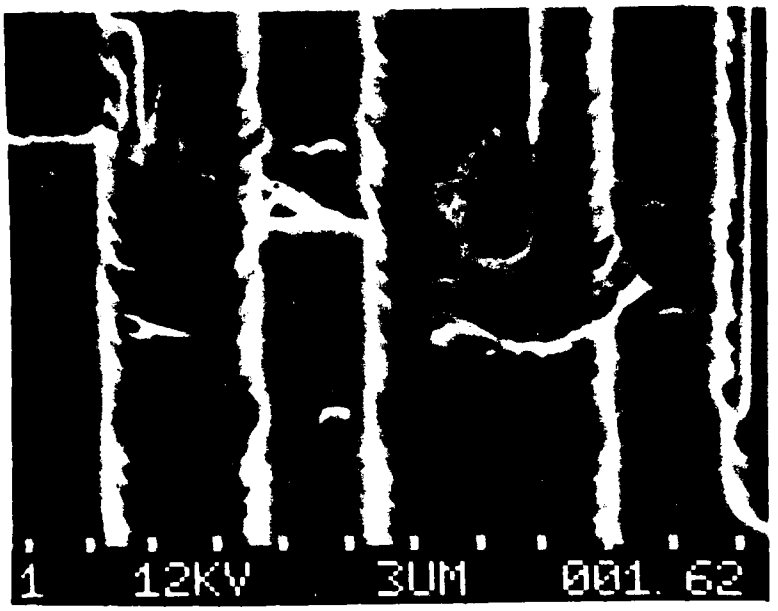
Figure V.A.27 - CD Stress, SEM Micrograph of Pin 7 Input Polysilicon Damage

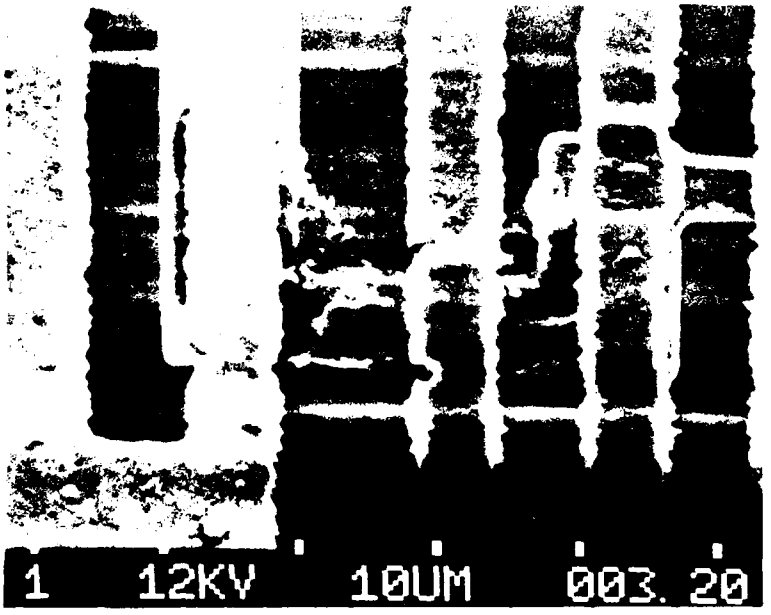
Figure V.A.28 - CD Stress, SEM Micrograph of Pin 9 Input Polysilicon Damage

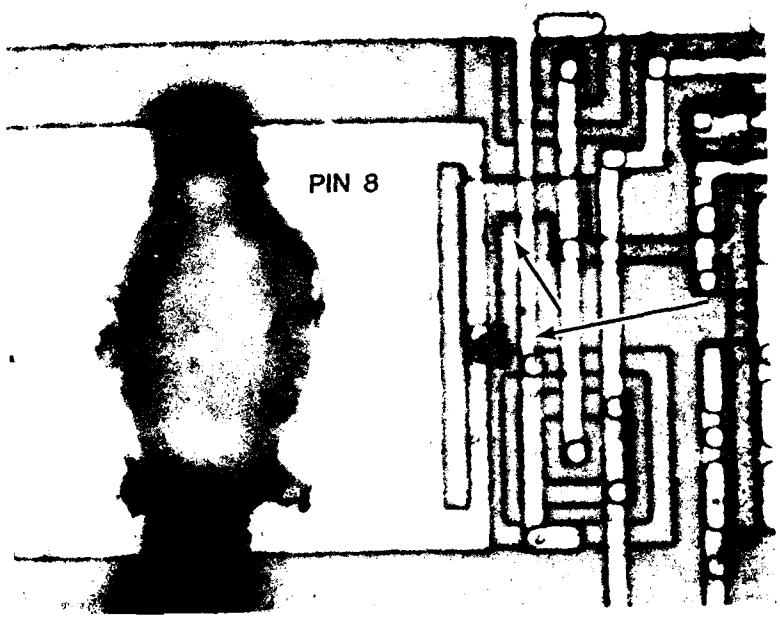
Figure V.A.29 - CD Stress, SEM Micrograph of Pin 8 Input Polysilicon Damage

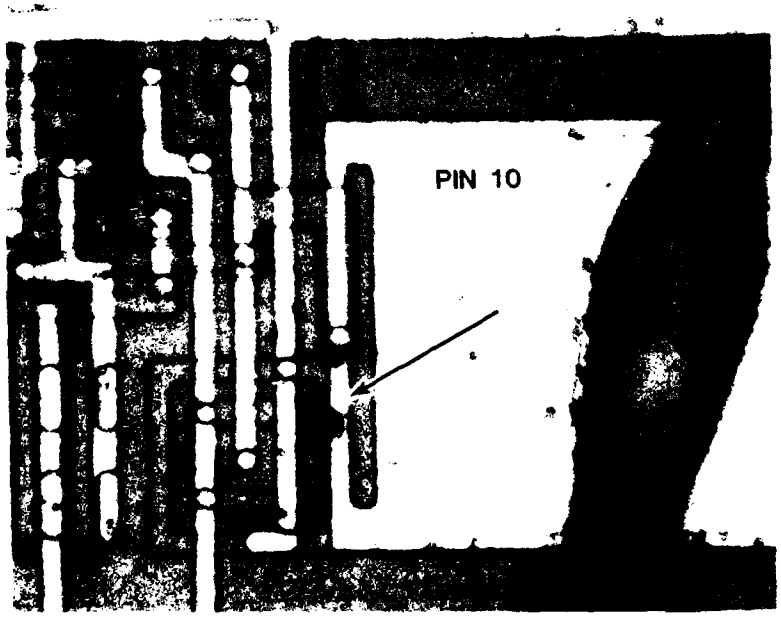
Figure V.A.30 - CD Stress, Pin 10 Breakdown Site from Metallization to Silicon

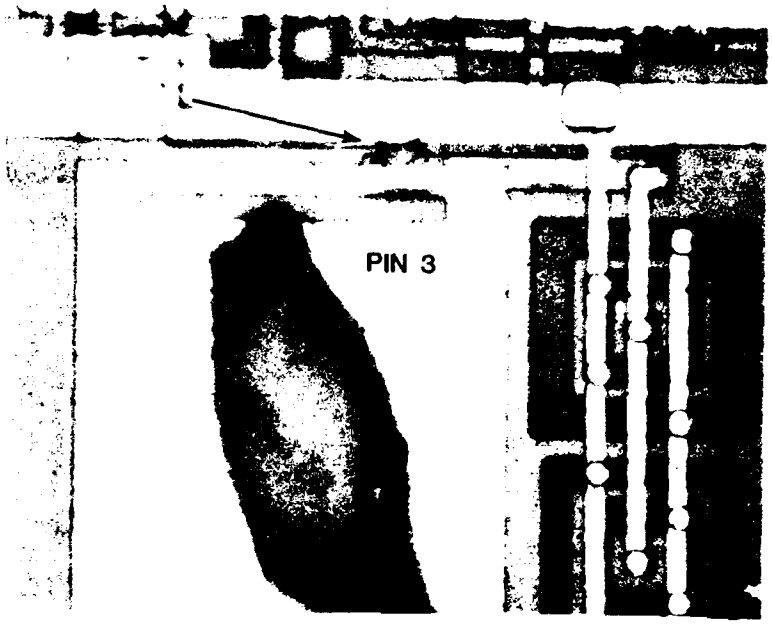
Figure V.A.31 - CD Stress, Pin 3 Input Polysilicon Damage

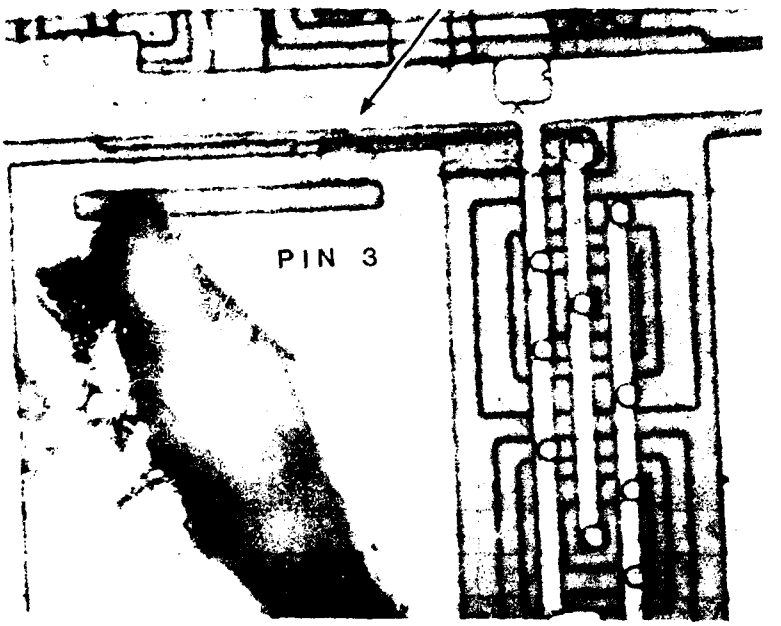
Figure V.A.36 - HBD Stress, Pin 3 Input Polysilicon Damage

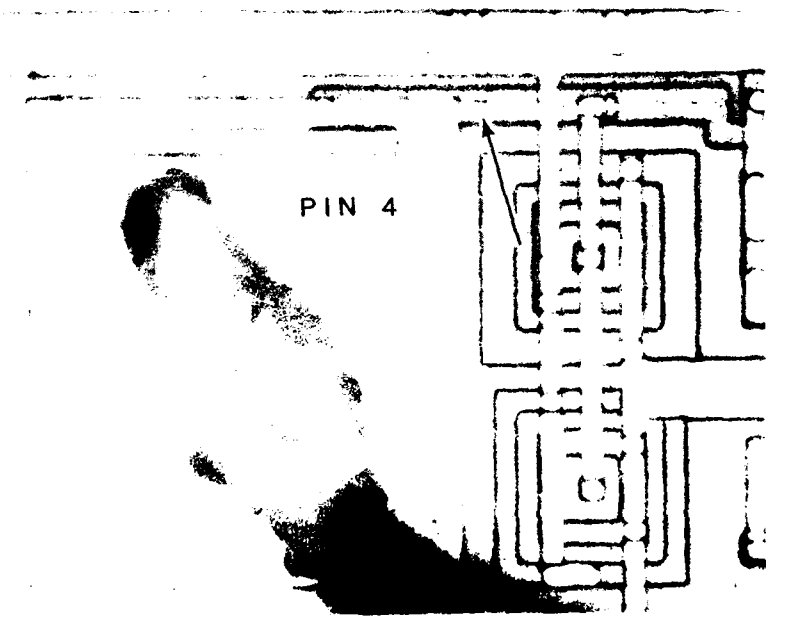
Figure V.A.37 - HBD Stress, Pin 4 Input with Minor Polysilicon Damage

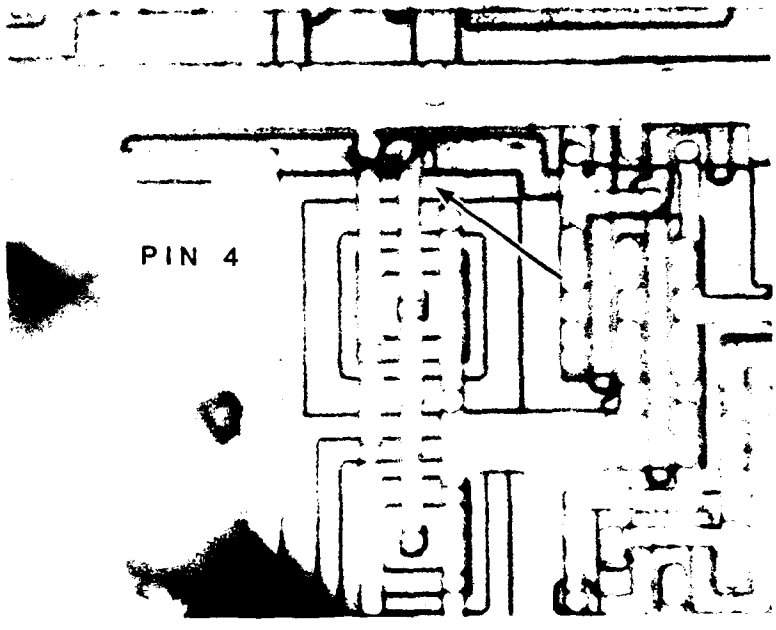
Figure V.A.38 - HBD Stress, Pin 4 Input Polysilicon Damage

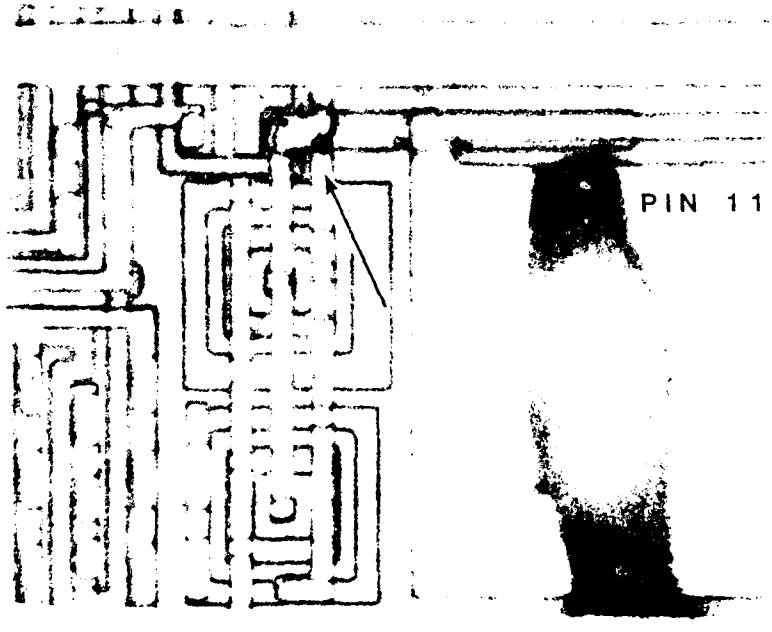
Figure V.A.41 - HBD Stress, Pin 11 Input Polysilicon Damage

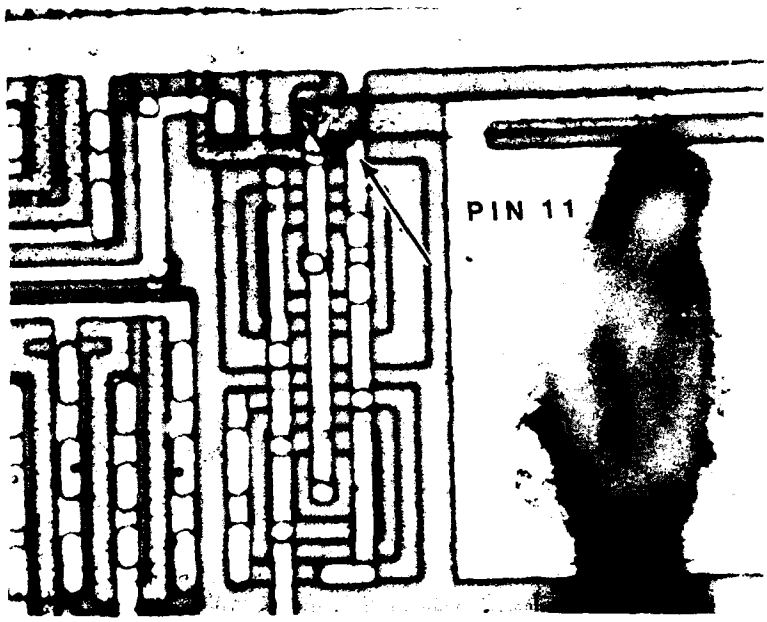
Figure V.A.42 - HBD Stress, Pin 11 Input Polysilicon Damage

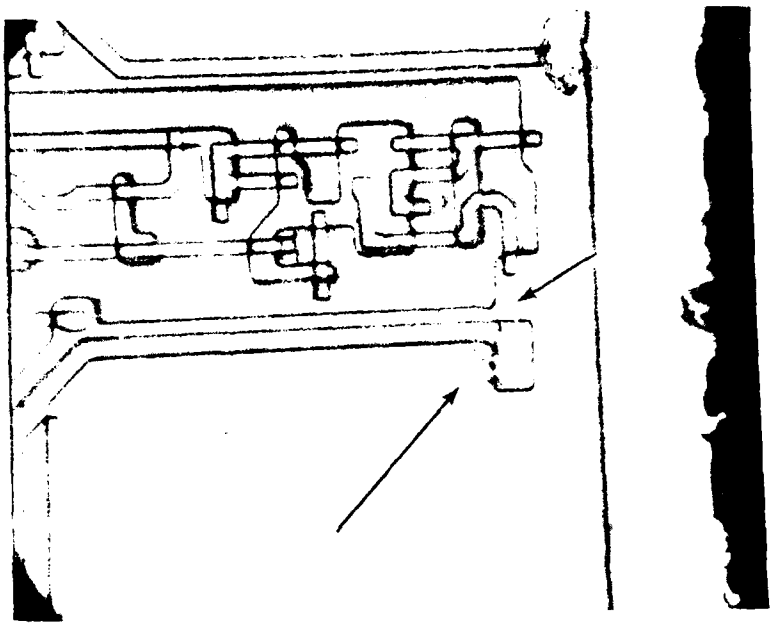
Figure V.B.21 - CD Stress, Pin 22 Input Damage

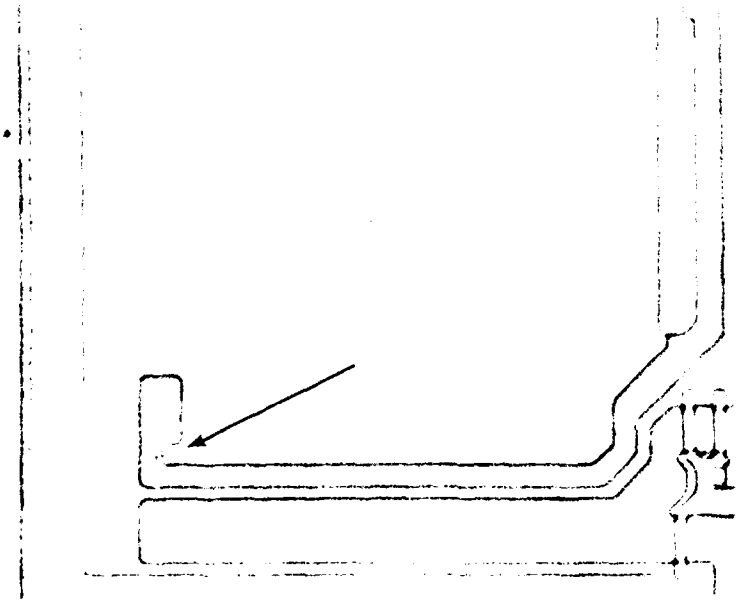
Figure V.B.22 - CD Stress, Pin 5 Input Damage

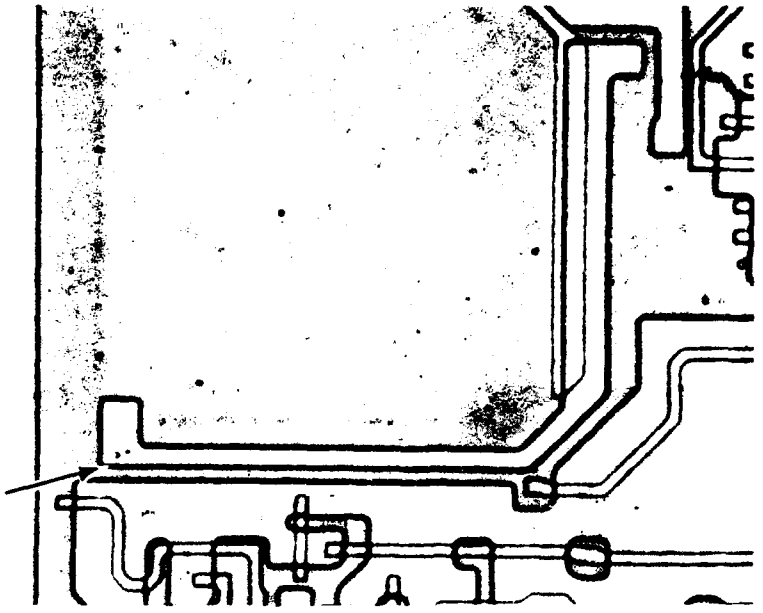
Figure V.B.23 - CD Stress, Pin 4 Input Damage

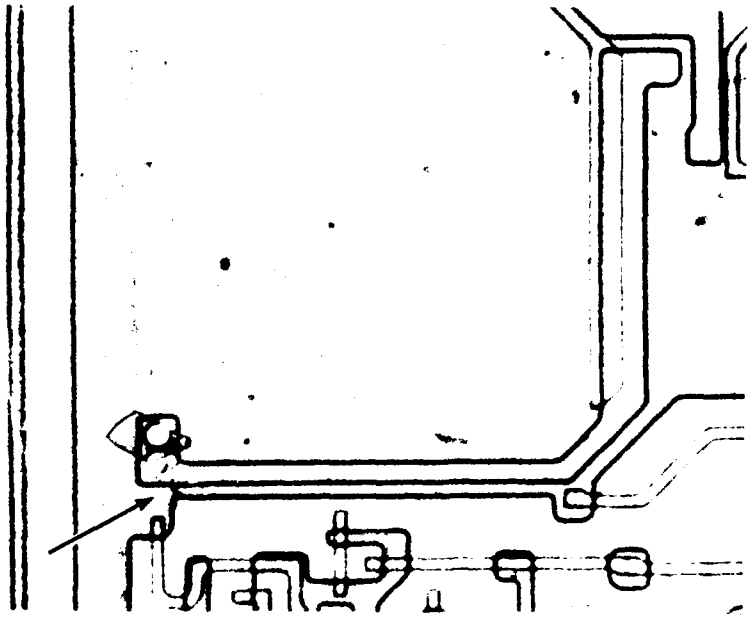
Figure V.B.24 - CD Stress, Pin 3 Input Damage

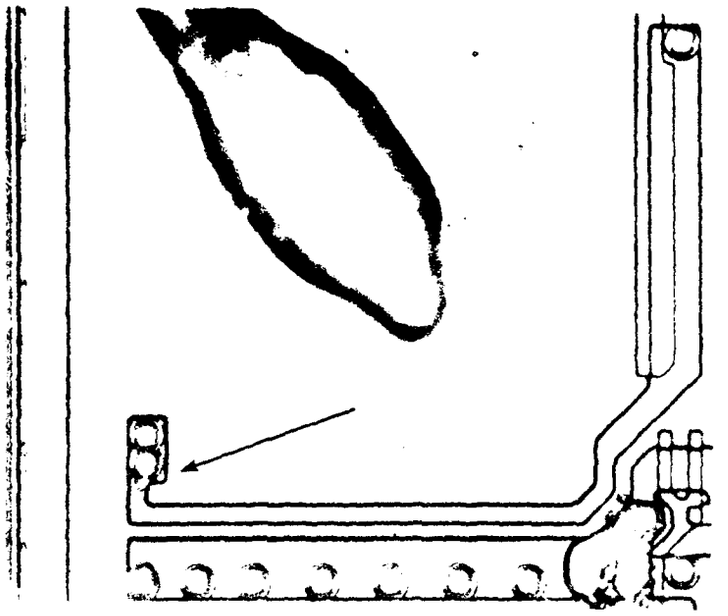
Figure V.B.28 - HBD Stress, Pin 5 Input Damage

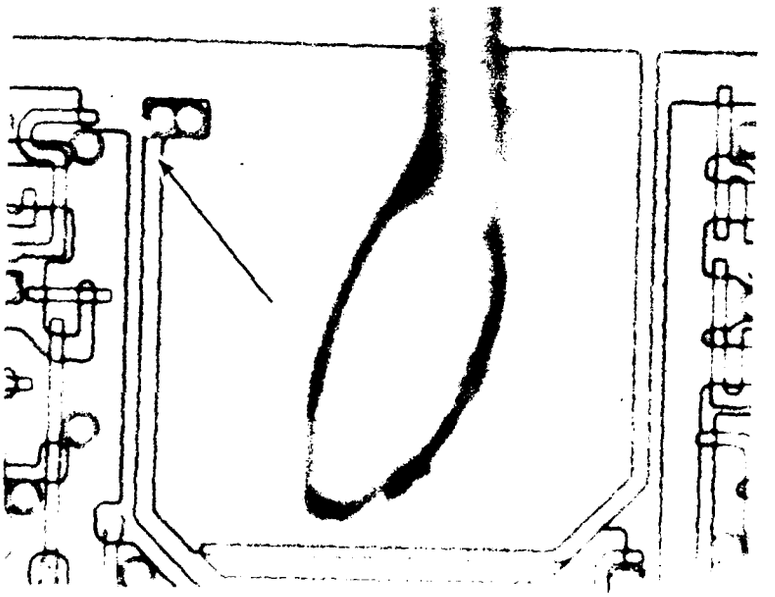
Figure V.B.29 - HBD Stress, Pin 22 Input Damage

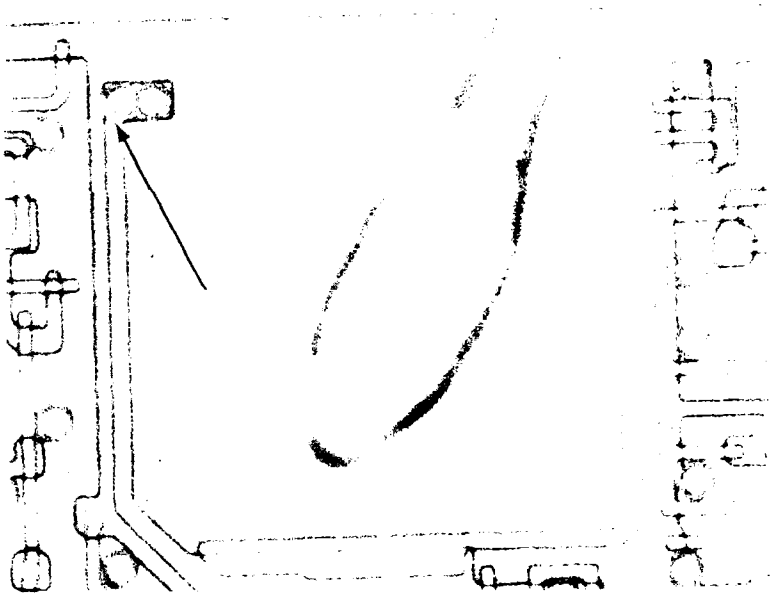
Figure V.B.30 - HBD Stress, Pin 21 Input Damage

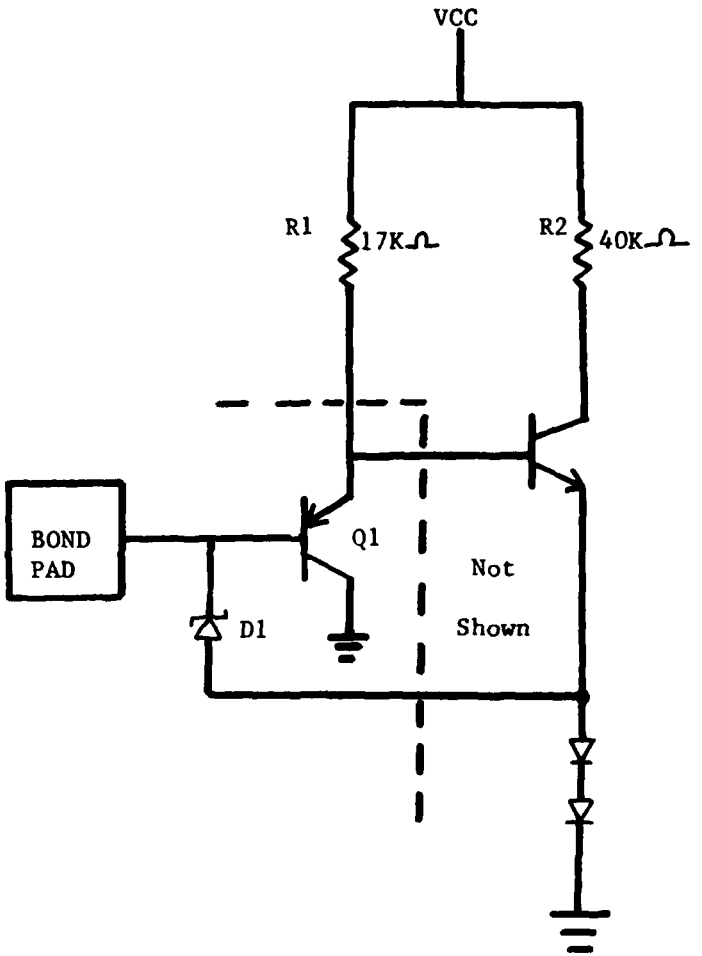
Figure V.C.5 - Input Schematic

Visual inspection found no apparent damage on the inputs which had excessive leakage current. Various failure analysis techniques were used to locate the failures. Input to ground electrical measurements found that the damage on pins 1 and 11 created leakage at low voltage levels, i.e. 10 microamps at 0.2 volts. The damage on pins 2 through 9 created leakage at a higher voltage level, i.e. 10 microamps at 2.0 volts. Inputs 1 and 11 developed degraded base/collector junctions while inputs 2 through 9 developed degraded D1 diodes (reference Figure V.C.5).

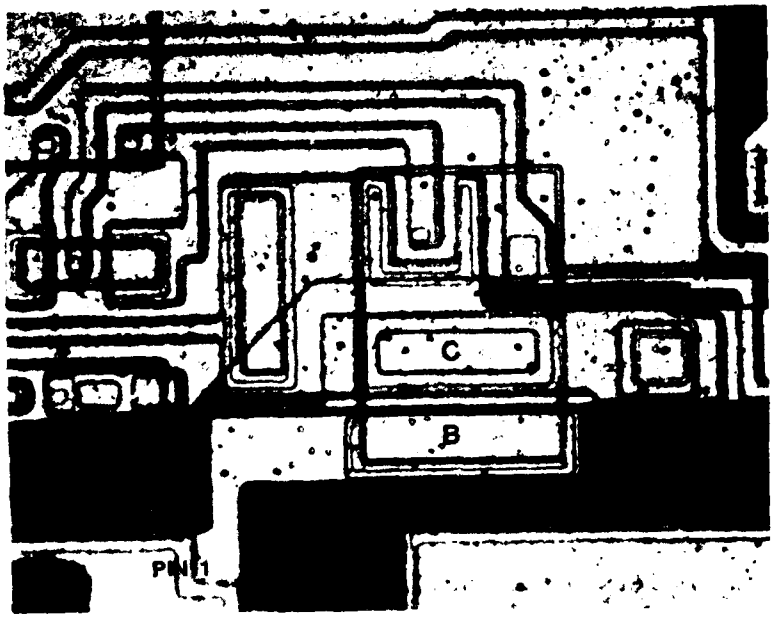
Figure V.C.14 - Pin 1 Input

The input pin layouts are shown in Figures V.C.14 through 18. Figure V.C.14 shows pin 1 and Figure V.C.15 shows pin 11. These inputs have similar layouts. The junction which became leaky was the base/collector and this is labeled. This is the standard PNP input with the base connected to the input pin and the collector connected to ground.

Pins 1 and 11 are not very susceptible to damage. The base/collector junction is much more tolerant of ESD stress than the Schottky diode. Pins 2, 3, 8 and 9 are much less susceptibe to damage than pins 4, 5, 6 and 7. This is due to the longer metallization in series with the discharge path.

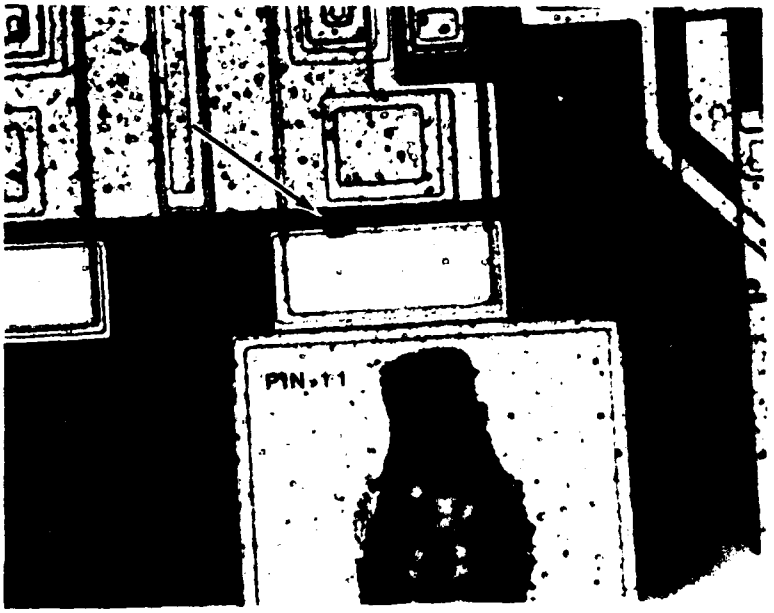
Figure V.C.19 - Pin 11 Input Failure Location.

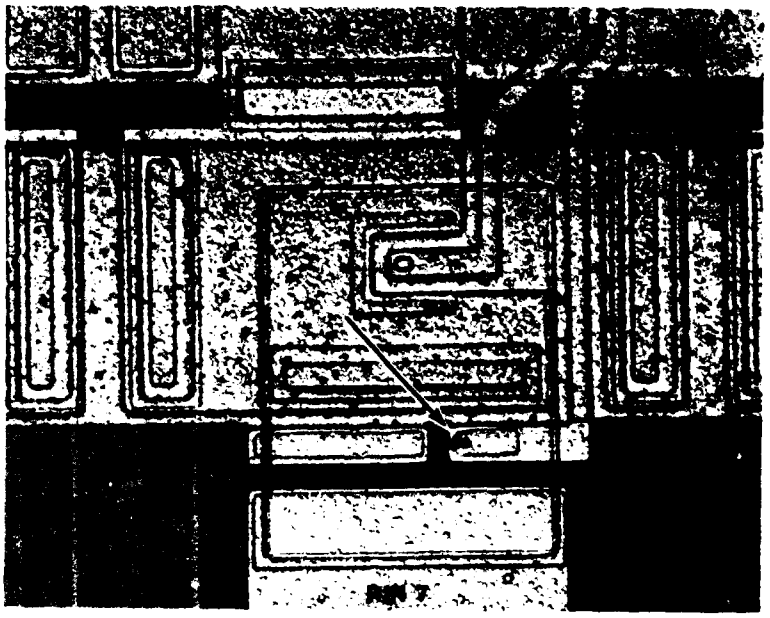
Figure V.C.20 - Pin 7 Input Failure Location.

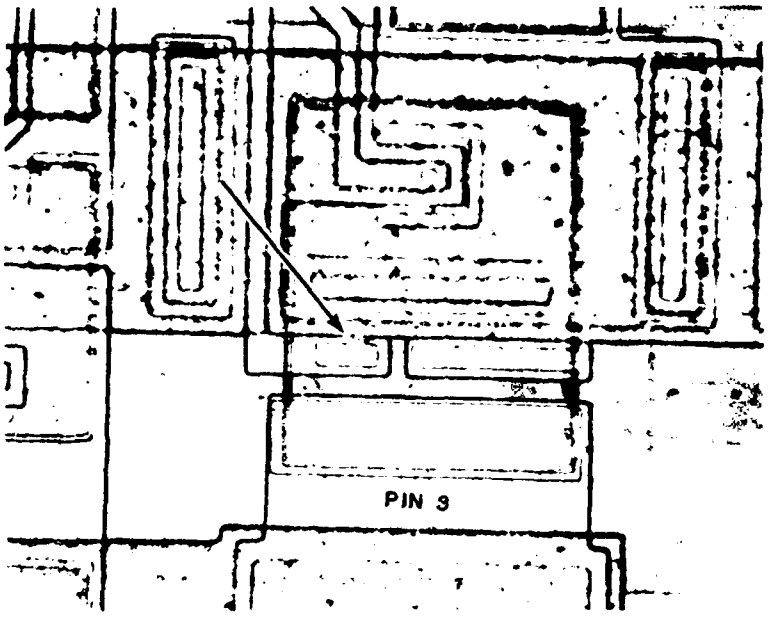
Figure V.C.23 - HBD Stress, Pin 3 Input Damage

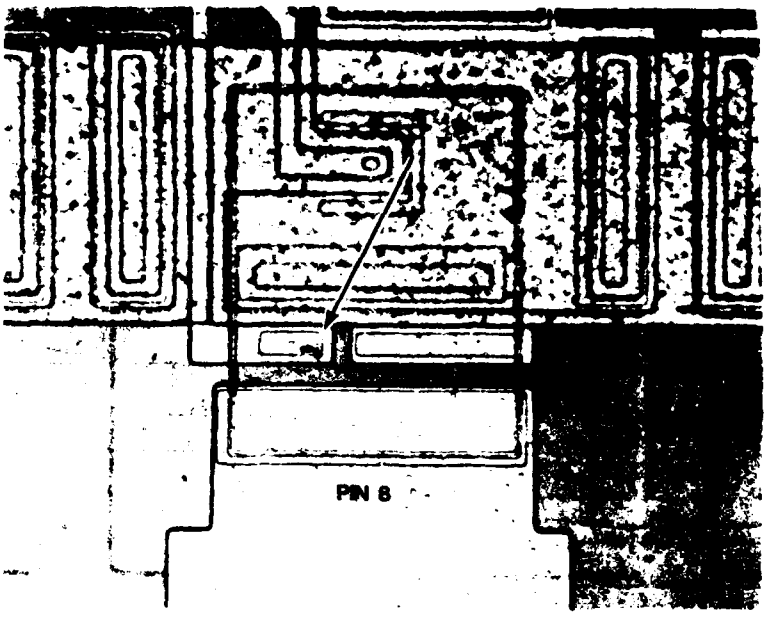
Figure V.C.24 - HBD Stress, Pin 8 Input Damage

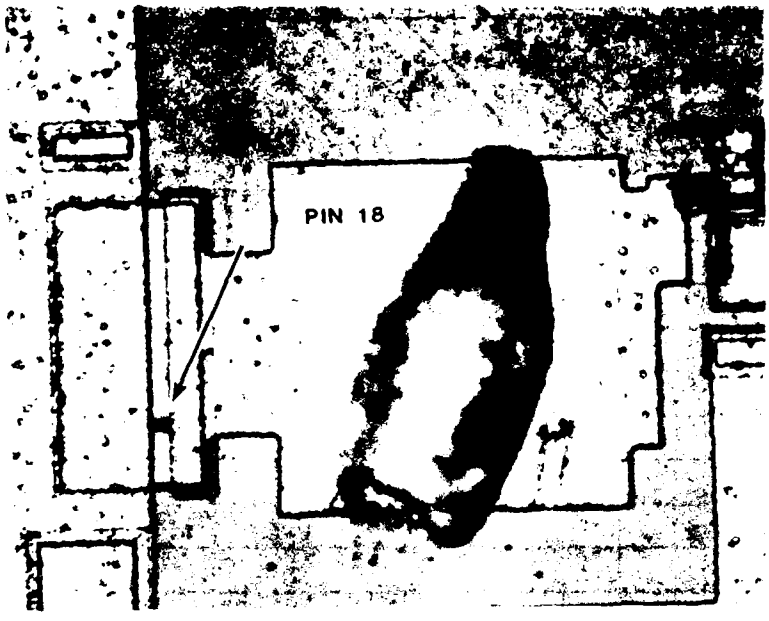
Figure V.D.14 - CD Stress, Input Pin 18 Damage Site

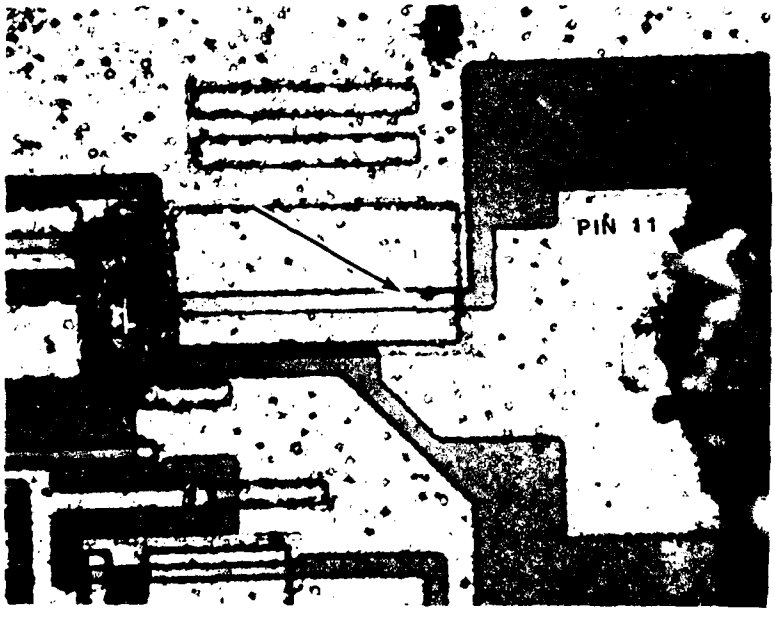
Figure V.D.15 - CD Stress, Input Pin 11 Damage Site

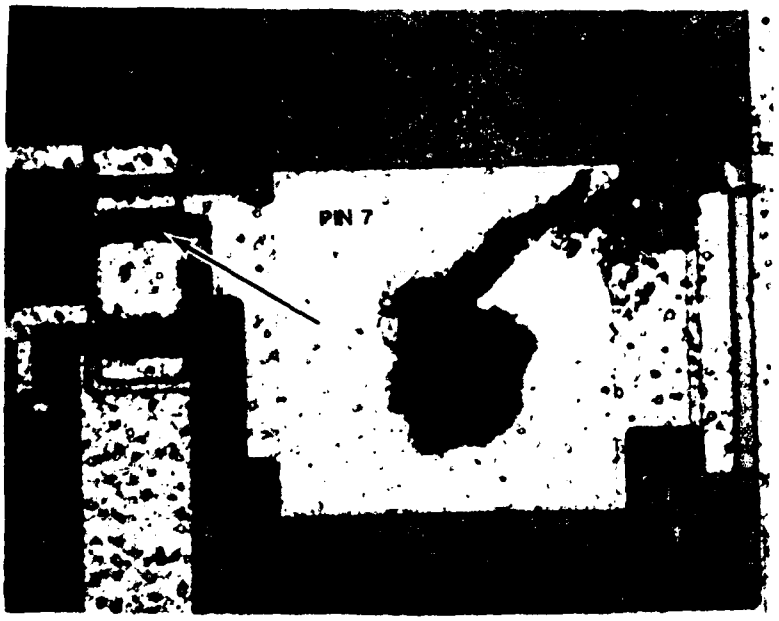
Figure V.D.18 - HBD Stress, Input Pin 7 Damage Site

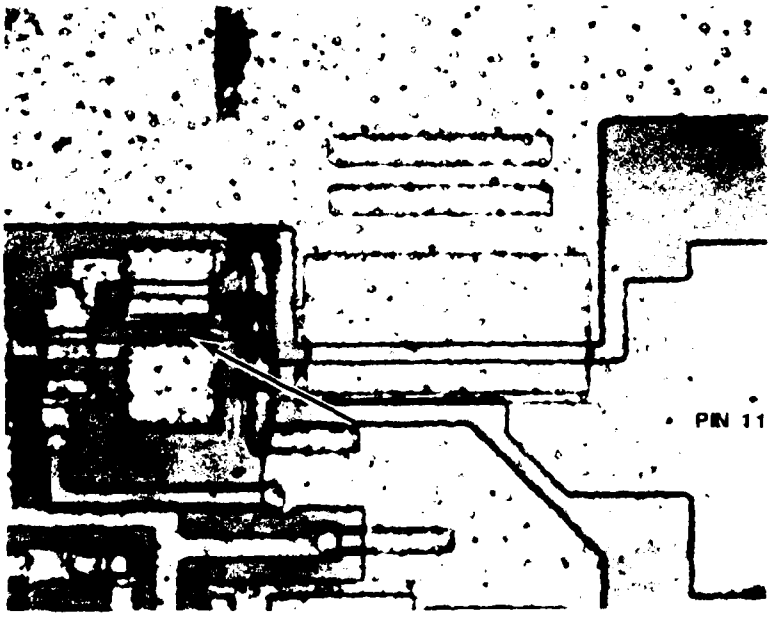
Figure V.D.19 - HBD Stress, Input Pin 11 Damage Site

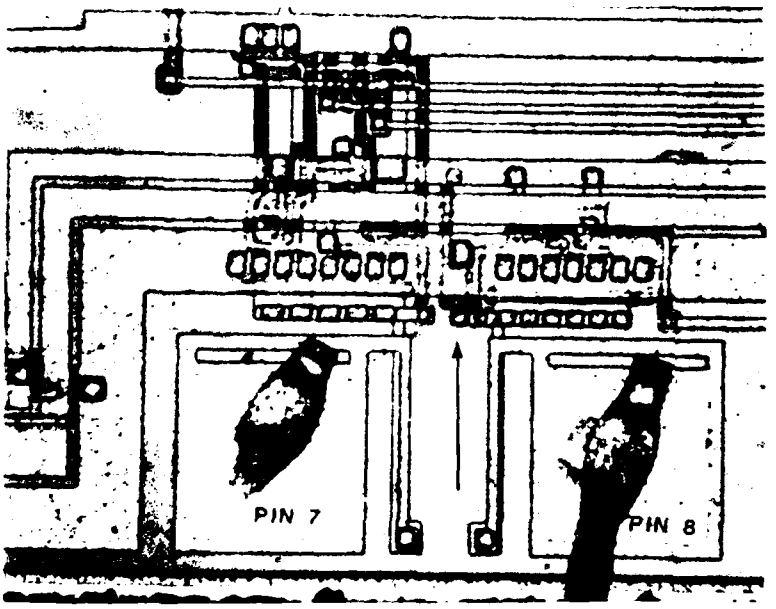
Figure V.E.20 - Input Pins 7 and 8, Arrow Indicates Extra Diffusion Contact

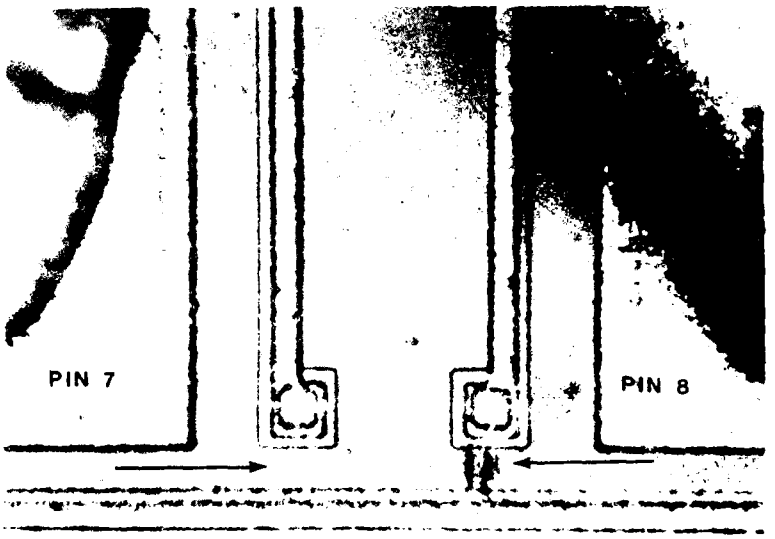
Failure appearance on serial number 20 is documented in Figures V.E.24 and V.E.25. This is pins 7, 8, and 9. The current path is from the n-type resistor to the n-type diffusion around the perimeter of the die. This latter diffusion is not connected to any other point so the current flows from it back to a grounded pin.

Figure V.E.24 - CD Stress, Damage on Pins 7 and 8

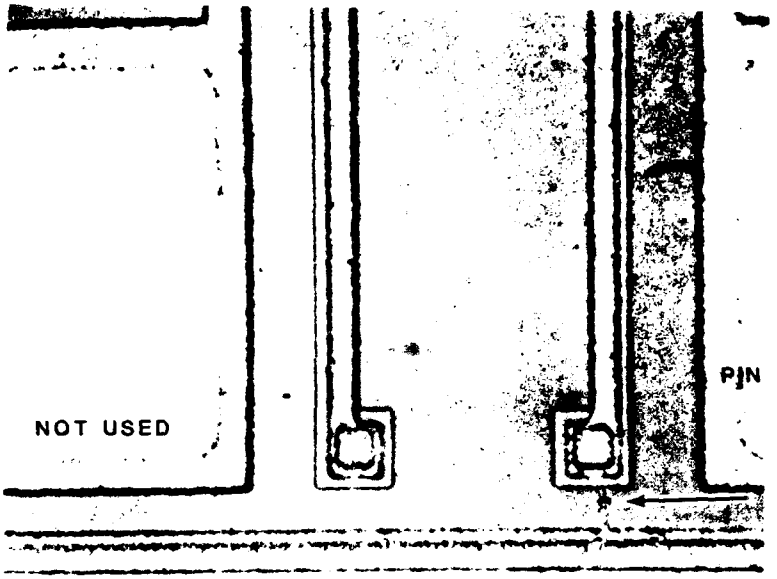
Figure V.E.25 - CD Stress, Damage on Pin 9

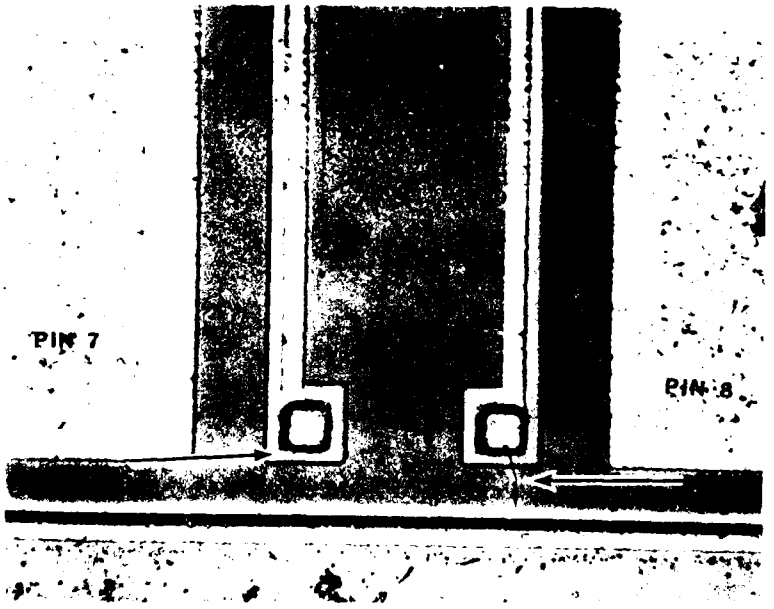
The failures on pins 7 and 8 on serial number 21 are shown in Figure V.E.26. The failure on pin 2 (input/output) is different than the failures on the inputs (Figure V.E.27). The breakdown sites which indicate the direction of the current are on the edge of the resistor contact closest to pin 3. The distance from the edge of the pin 2 resistor diffusion to the edge of the pin 3 resistor diffusion is 26 microns. This is shorter than the distance to the edge of the die (32 microns). The damage created indicates that a stress occurred between pins 2 and 3. Numerous pairs of input/output pins had this same spacing between resistors (26 microns) but they were not damaged. This indicates that the damage on pin 2 was not the result of a stress originating at pin 2 but rather was the result of an opposite polarity pulse originating at pin 3. The close spacing to the adjacent pin resulted in the stress occurring between these points rather than to the edge of the die.

Figure V.E.26 - CD Stress, Damage on Pins 7 and 8

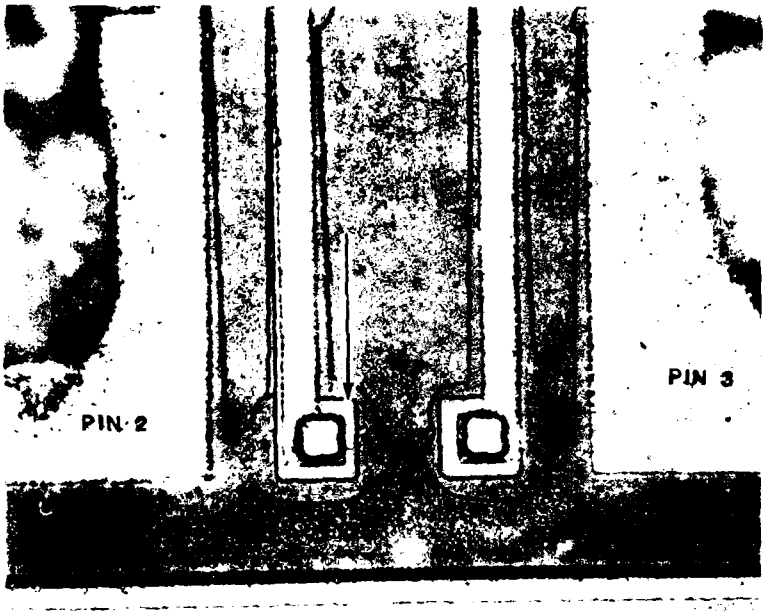
Figure V.F.27 - CD Stress, Damage on Pins 2 and 3

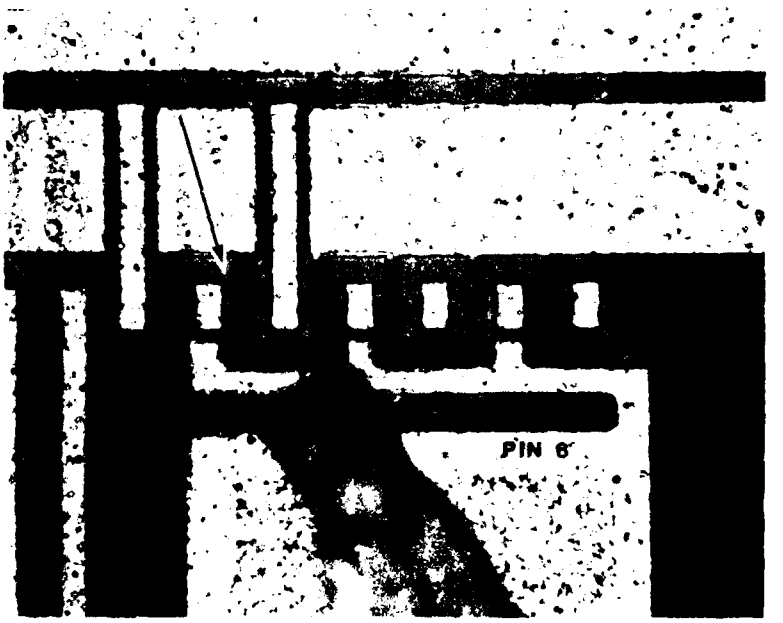
Figure V.F.28 - CD Stress, Pin 6 Output Damage

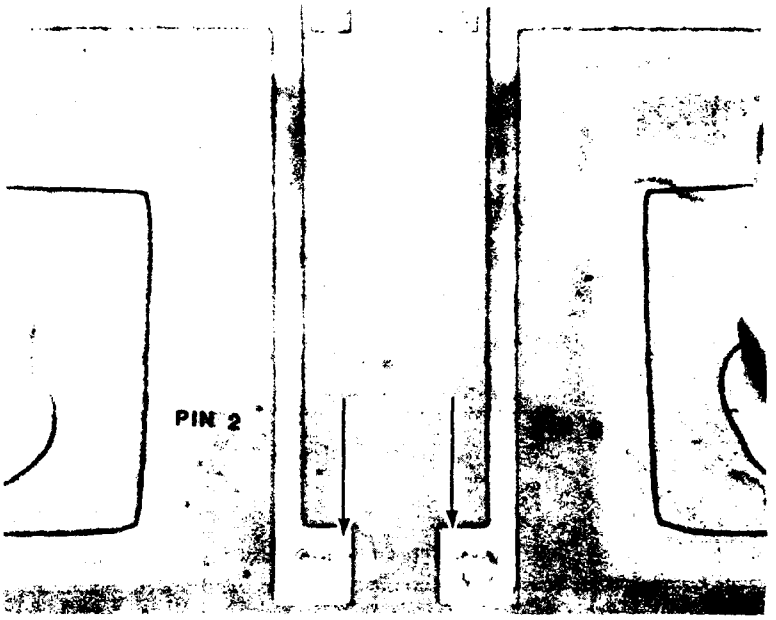
Figure V.E.30 - HBD Stress, Damage on Pins 2 and 3

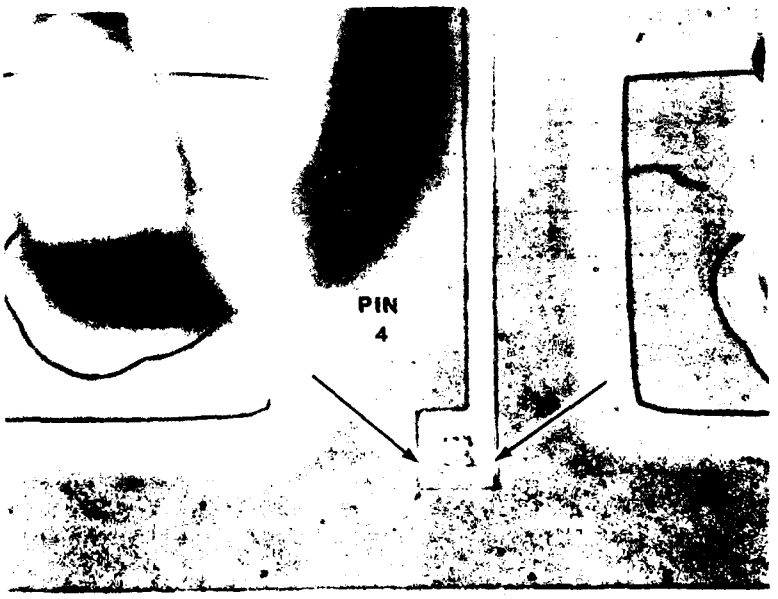
Input/output pins 2 and 12 were the only two I/O pins which exhibited visible damage. They both had leakage currents of 1 microamp at 10 volts. The input pins generally had damage on the side of the resistor closest to the edge of the die. There is also visible damage along the edge of the n-diffusion on the perimeter of the die.

Figure V.E.31 - HBD Stress, Damage on Pin 4

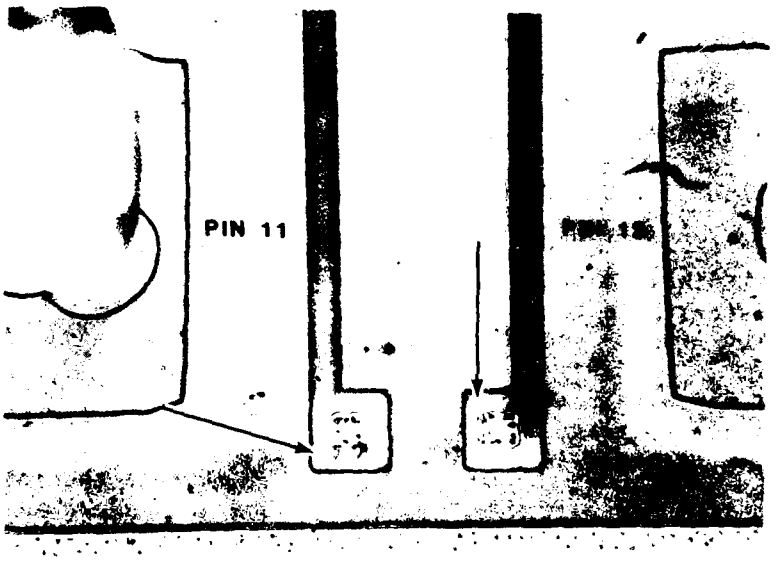
Figure V.E.33 - HBD Stress, Damage on Pins 11 and 12

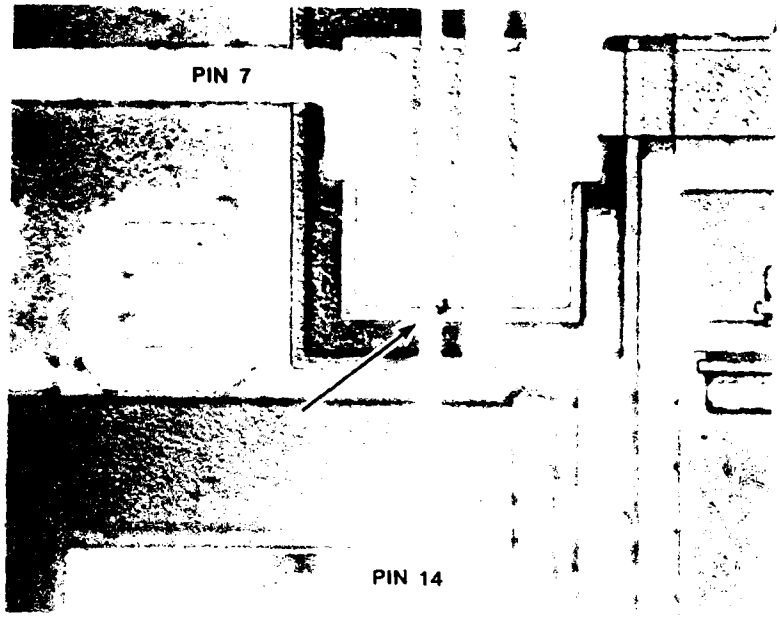
Figure V.F.17 - CD Stress, Pin 7 to Pin 14 Short

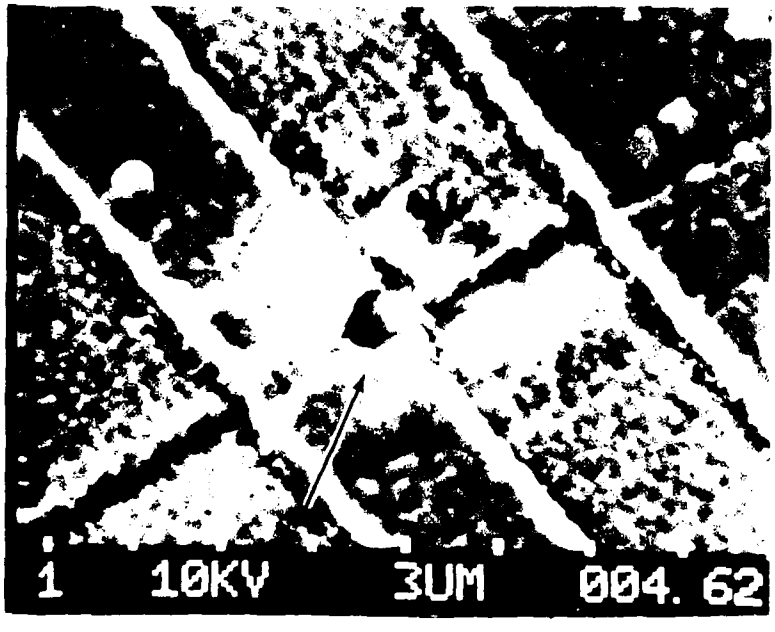
Figure V.F.18 - CD Stress, SEM Micrograph of Pin 7 to Pin 14 Damage

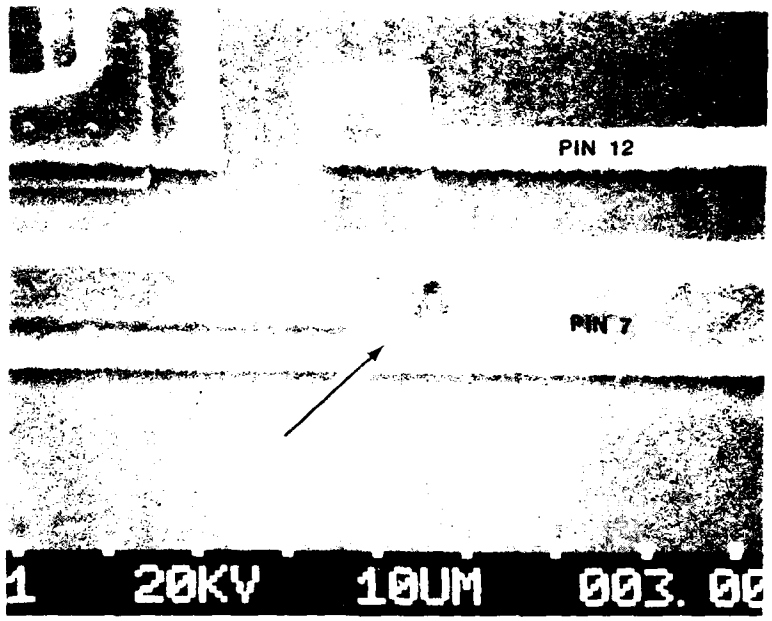
Figure V.F.21 - CD Stress, Short Between Pins 7 and 12

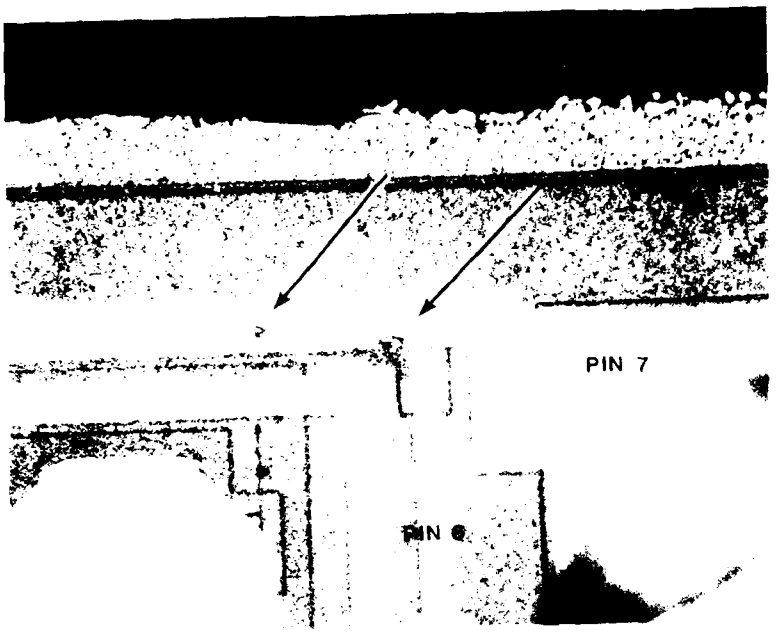
Figure V.F.24 - HBD Stress, Pin 6 to Pin 7 Damage

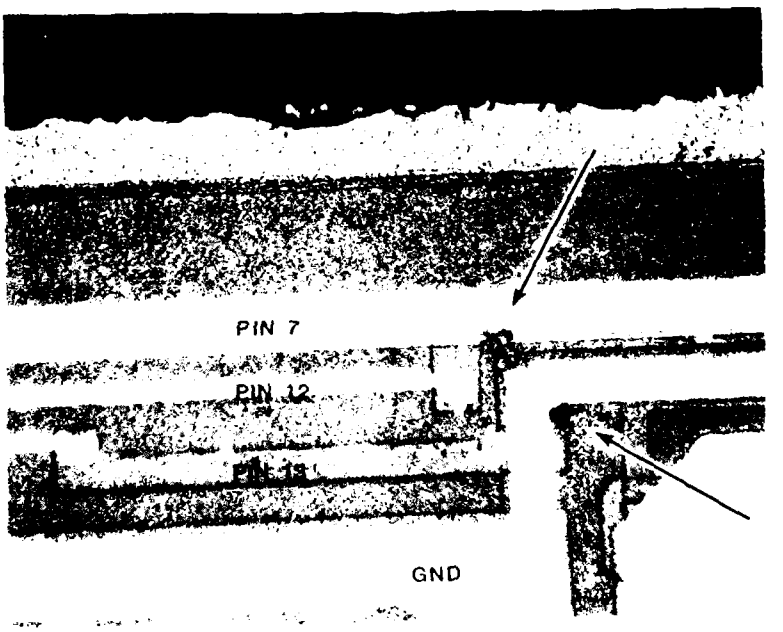
Figure V.F.25 - HBD Stress, Damage Sites Between Pins 7 and 12 and Between Pin 13 and GND
